Concrete Repair and Protection - Odlums Flour Mill

Facade Restoration, Concrete repair, Anticarbonation protective coatings, Joint replacement.

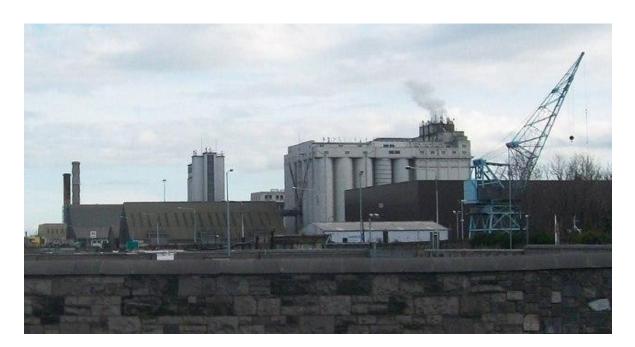
A full investigation of the concrete elements was carried out by our specialist team who accessed the difficult elevations by abseiling from the roof structure. The survey identified low cover and honeycombing from inadequate compaction in the original construction as the main issues. Our detailed findings enabled the project manager to compile a detailed specification and method statement for the works. After a competitive tender process, Larsen Contracts were successful in securing appointment as Main Contractor for the works.

The scope of work included the high pressure cleaning of the structure, identification of the defects, mechanical demolition and blast cleaning of the reinforcing steel. Defective concrete was repaired using Weber's hand placed concrete repair mortar system. The facade was then treated using Weber's high performance elastomeric anti-carbonation coating to provide long term protection to the concrete elements.
